*This current issue of **The PerioDontaLetter** addresses the designs which have been shown to have a connection with peri-implantitis and marginal bone loss, and how careful implant-supported prosthetic design can improve long-term oral health, reduce complications, and maintain stability around dental implants.*

The Influence of Prosthetic Designs On Peri-Implant Bone Loss

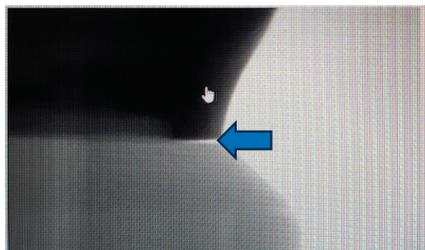
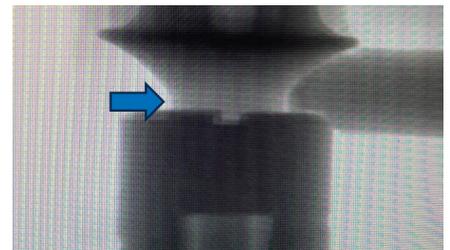
Figure 1. Bacterial leakage into and out of the implant-abutment connection is the primary cause of implant infection. Internal connections tend to have tighter seals with minimal micromovement, which reduces bacterial penetration and subsequent peri-implantitis.

The implant-abutment connection type also plays a critical role in peri-implant health the report concluded. (See Figure 1.)

The Report found internal connections tend to have tighter seals at the implant-abutment interface, which reduces the risk of bacterial penetration and subsequent peri-implantitis.

External connections are more prone to mechanical complications, such as screw loosening, and they create larger microgaps where bacteria can accumulate, leading to a higher risk of peri-implantitis.

The Report concluded external connections may still be used in specific cases where the implant system requires them, but they necessitate more careful monitoring and maintenance. (See Figure 1.)

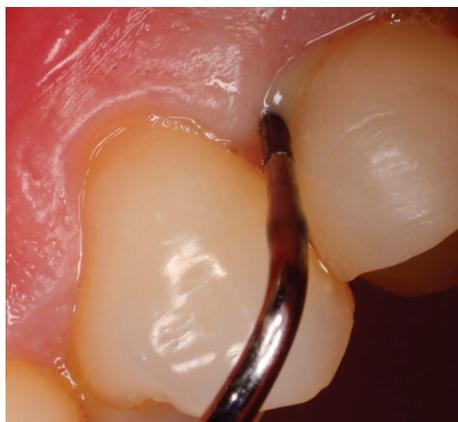
Figure 2. A 9mm pocket with suppuration reveals severe subgingival infection.

There is significant evidence that residual cement is a major factor causing peri-implantitis; so it is critical to be careful that the cement is “cleaned” around an implant prosthesis, or it will likely contribute to plaque retention, which in turn contributes to peri-implantitis. (See Figures 2 and 3.)

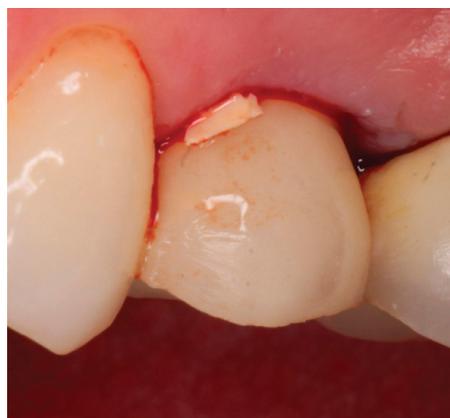
Figure 3. During debridement of the infected area, a large piece of subgingival cement, which was the primary etiology of the infection, was removed.

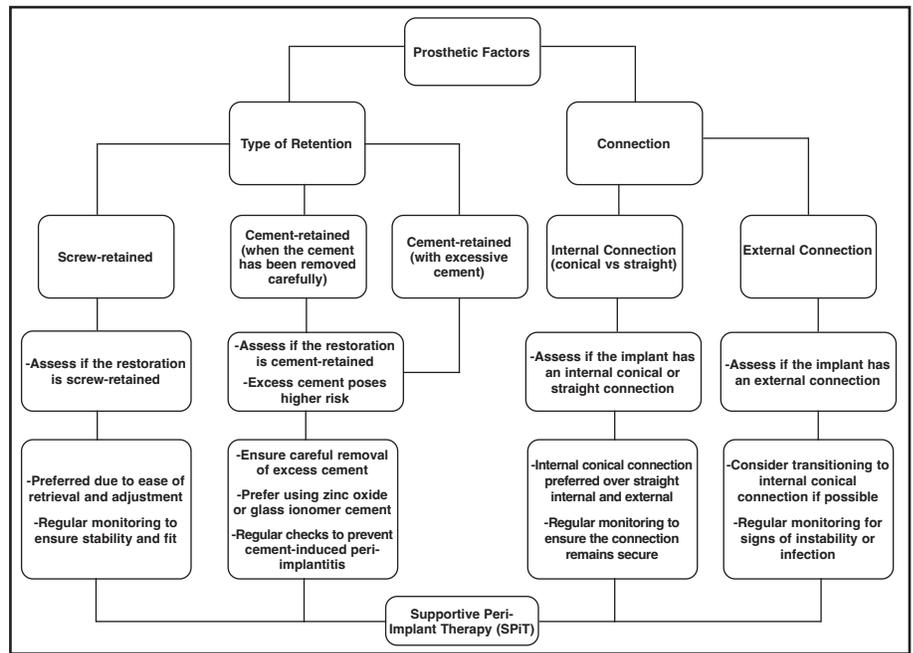
Figure 4. Flowchart of clinical recommendations for the retention and connection types as prosthetic risk factors. (See Figure 1.)

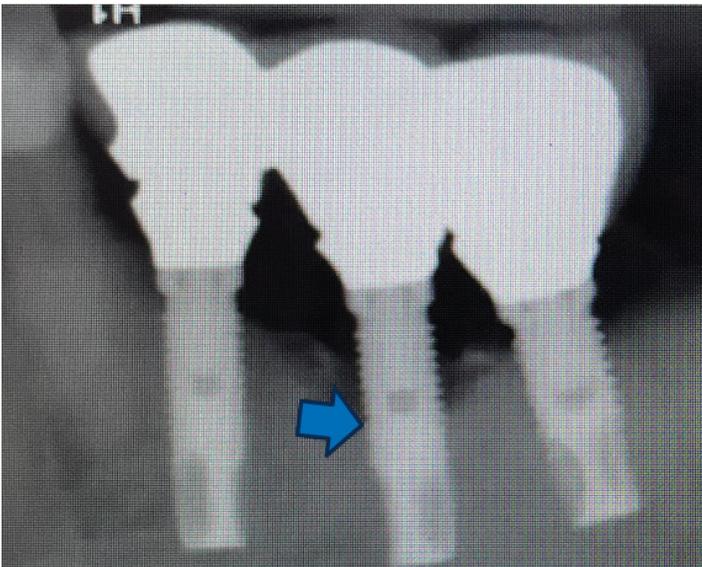
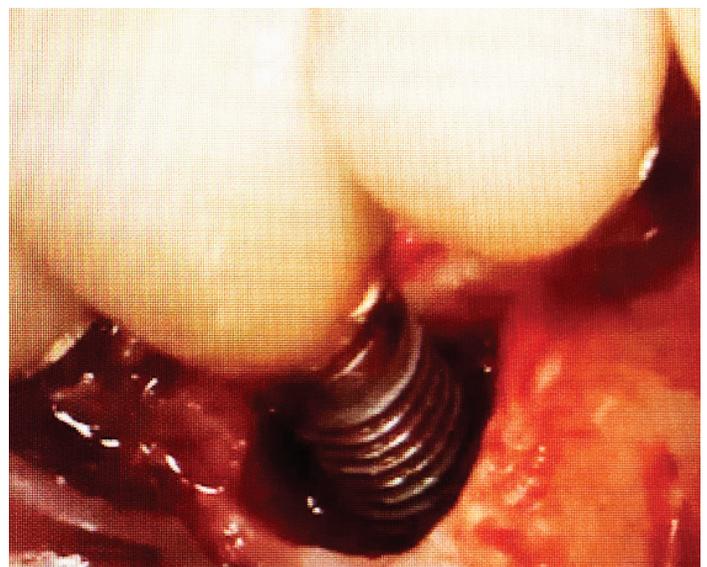
Figures 5 and 6. Recent studies have noted increased marginal bone loss, particularly in the middle implant, when more than two adjacent implants were splinted together.

Recent studies cited by the AAP/AO also noted increased marginal bone loss, particularly in the middle implant, when three adjacent implants were splinted together. (See Figures 5 and 6.)

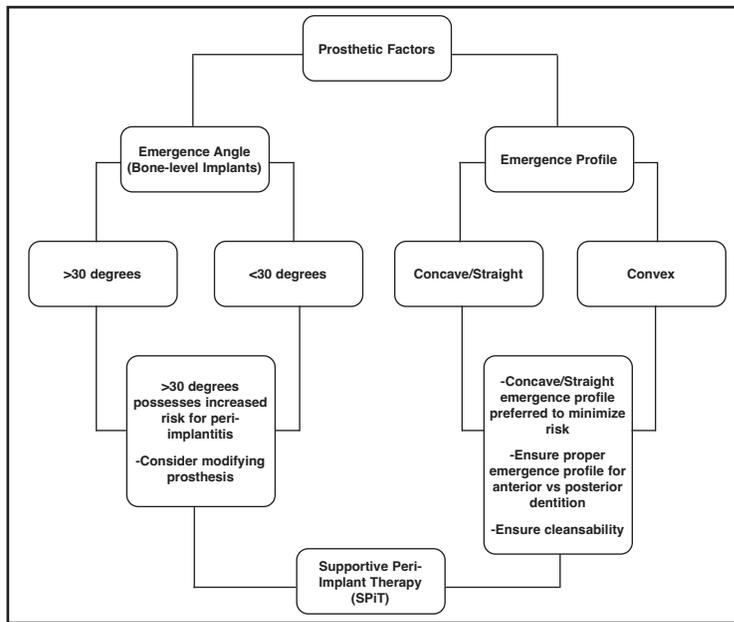
Figure 7. Flowchart of clinical recommendations for emergence angle and emergence profile as prosthetic risk factors. (See Figure 8 below.)

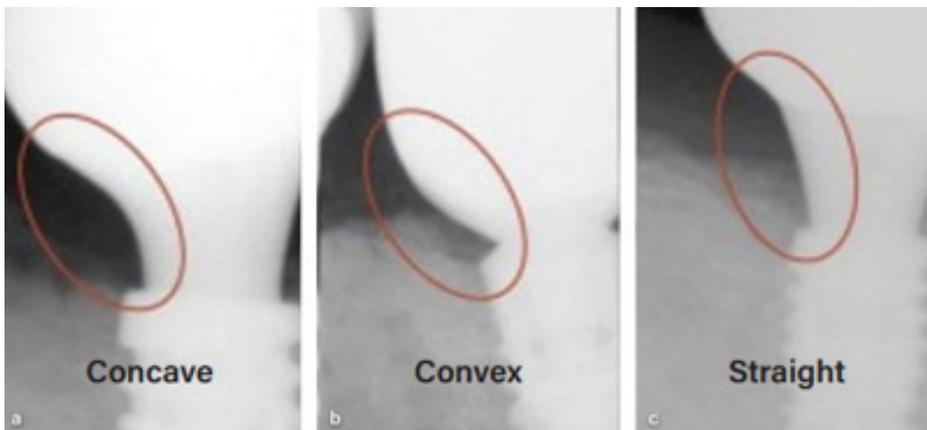
Figure 8. Radiographic examples of different implant emergence profiles: (a) concave, (b) convex, and (c) straight (best.) The convex profile will encourage plaque retention, which may lead to more bone loss.

Emergence angles $<30^\circ$ and a concave/straight profile led to a lower risk of peri-implantitis.

Emergence angles >30 degrees were identified as high risk due to the difficulty in accessing and cleaning these areas, which can lead to increased plaque accumulation.

The Report found a convex emergence profile is particularly problematic as it creates undercuts where plaque can easily accumulate, exacerbating the risk of peri-implant inflammation and bone loss.
